Technical Bulletin

New Lift Bar Configuration

FM-7.5-202
Rev A
08/29/05

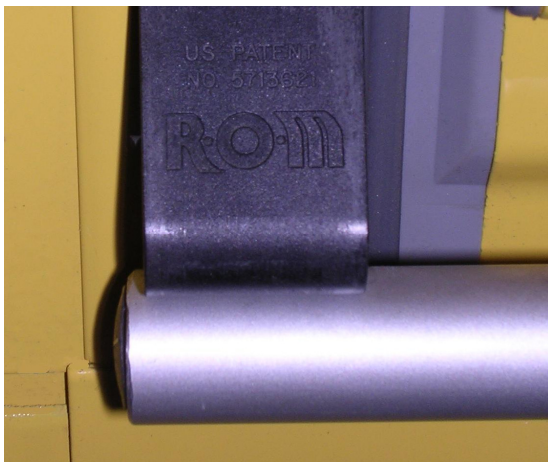
Previous Lift Bar Configuration

Before, if a compartment were made more than 1/4" too large, the magnet may not have consistently triggered the switch. This would require the installation of a shim to shove the door to the "switch side" of the compartment.

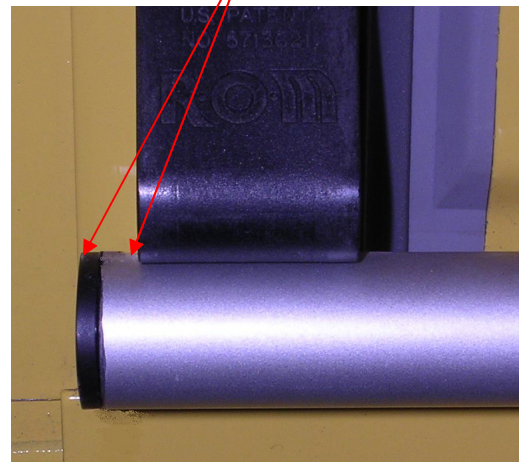
New Lift Bar Configuration

Lift Bar Has Been Extended

Now, our new lift bar configuration will eliminate the need for shimming. If the door will physically fit and operate with an out-of-tolerance door opening, the Door Ajar Switching System (DASS) will also work. This is accomplished by extending the length of the lift bar by approximately 5/16" past the strike blocks on each side. Also, the end caps have been redesigned to better match the profile of the lift bar.
